BANK EROSION STUDY

Ohio River Division Field
OHIO RIVER BANK
EROSION STUDY.

OHIO RIVER
BANK EROSION STUDY

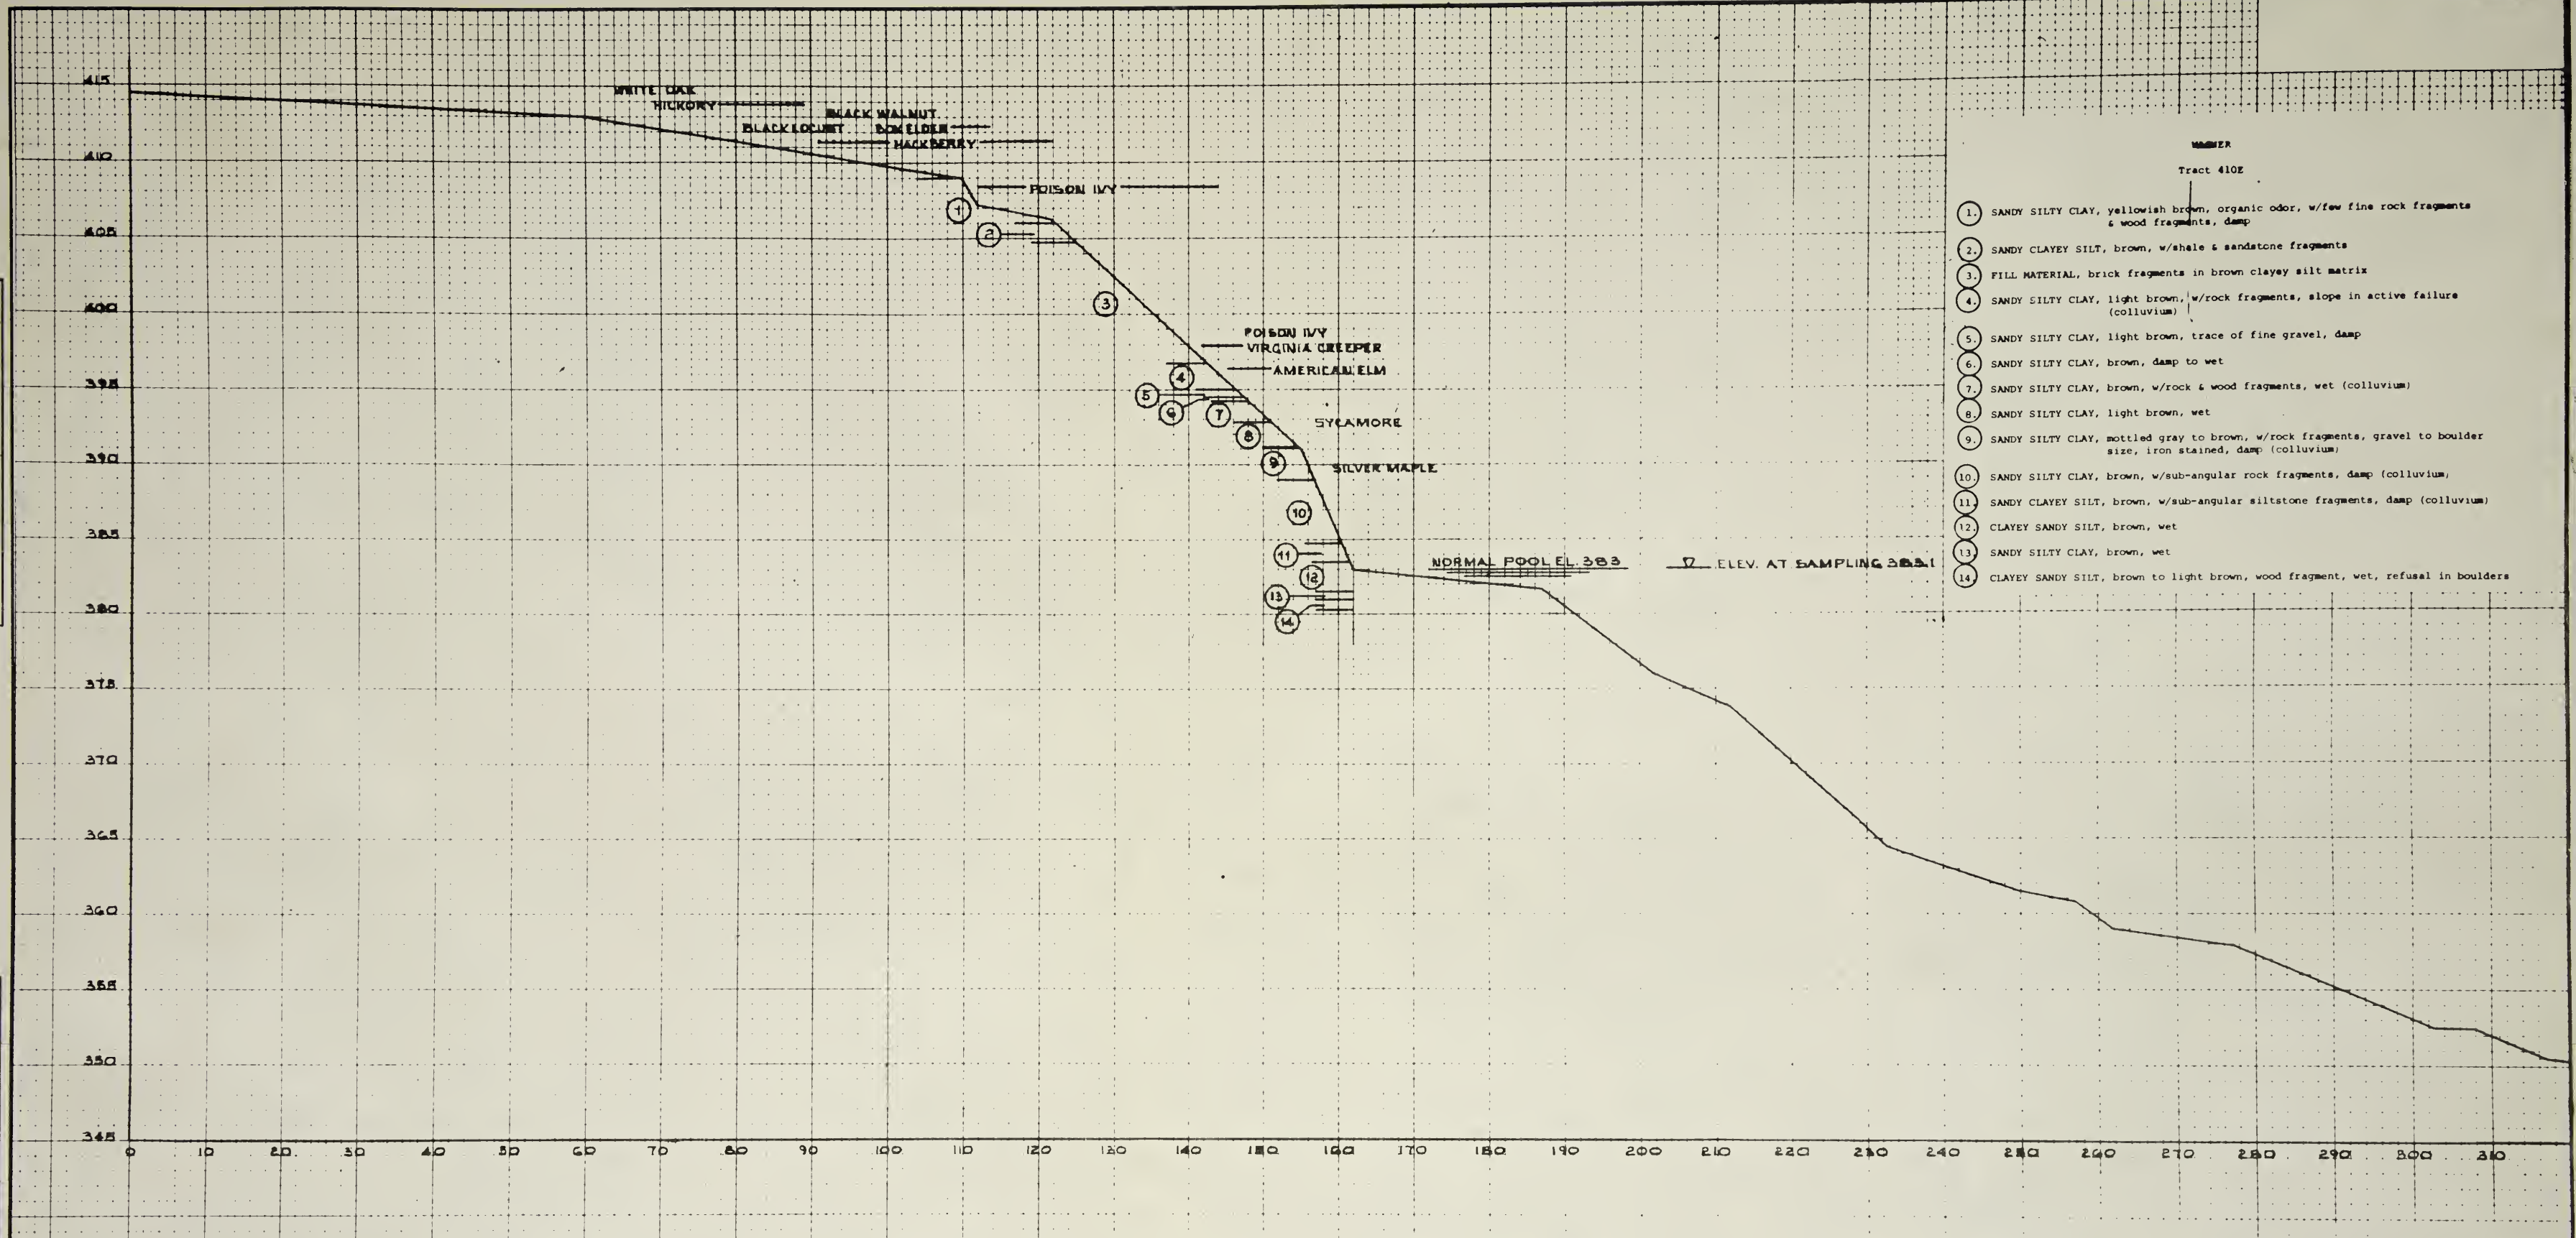
- Tract 410E
- 1. SANDY SILTY CLAY, yellowish brown, organic odor, w/few fine rock fragments & wood fragments, damp
 - 2. SANDY CLAYEY SILT, brown, w/shale & sandstone fragments

- 3. FILL MATERIAL, brick fragments in brown clayey silt matrix
 - 4. SANDY SILTY CLAY, light brown, w/rock fragments, slope in active failure (colluvium)

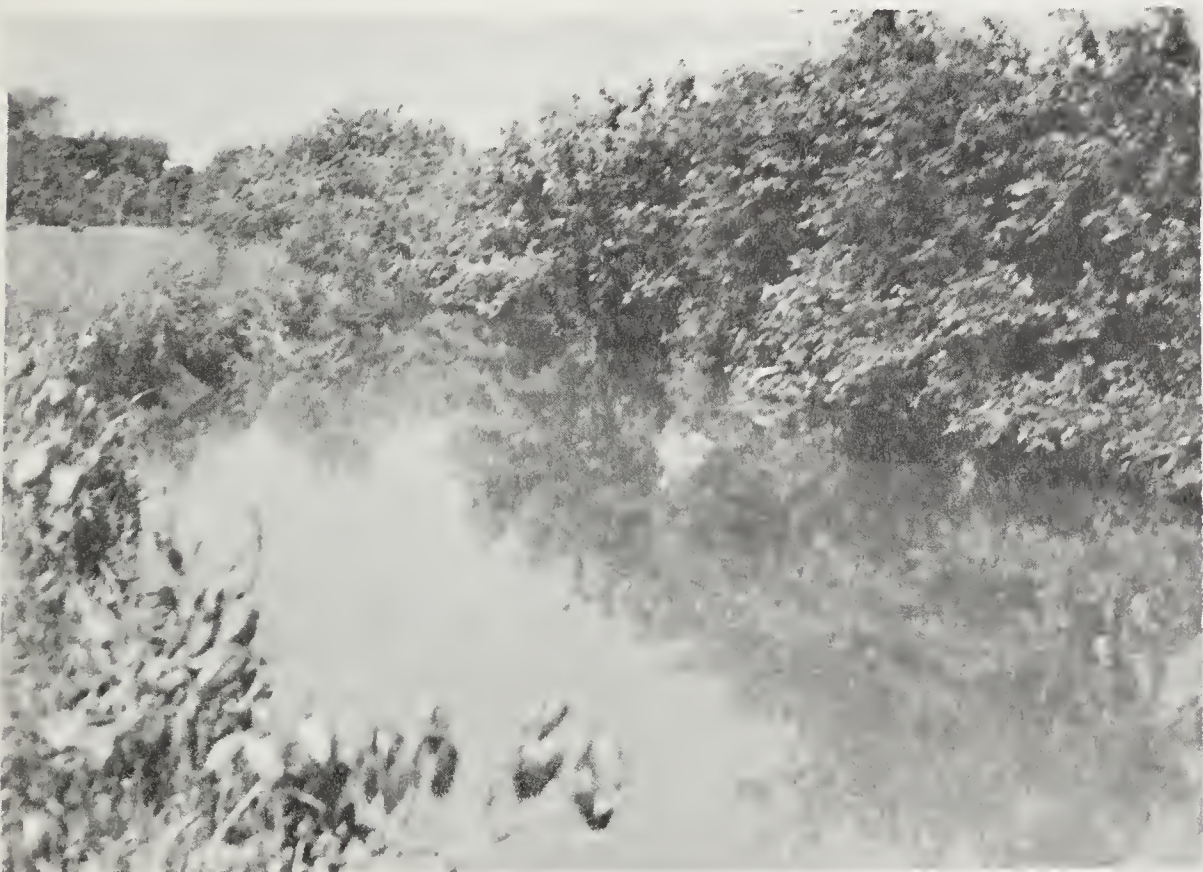
F

Drainway evidencing Ohio River backwater
conditions. 10 May 1977

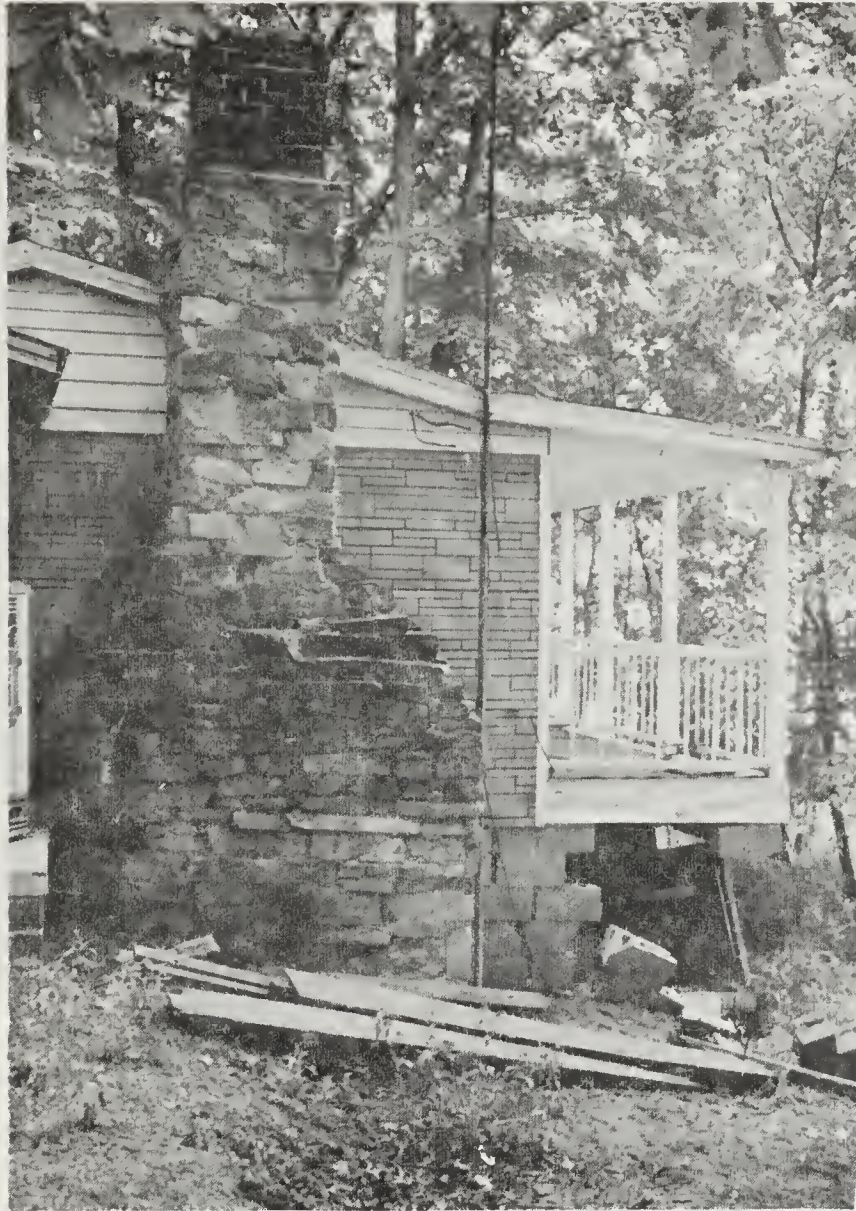
C

Structure on tract evidencing slide
related damage. 3 May 1977

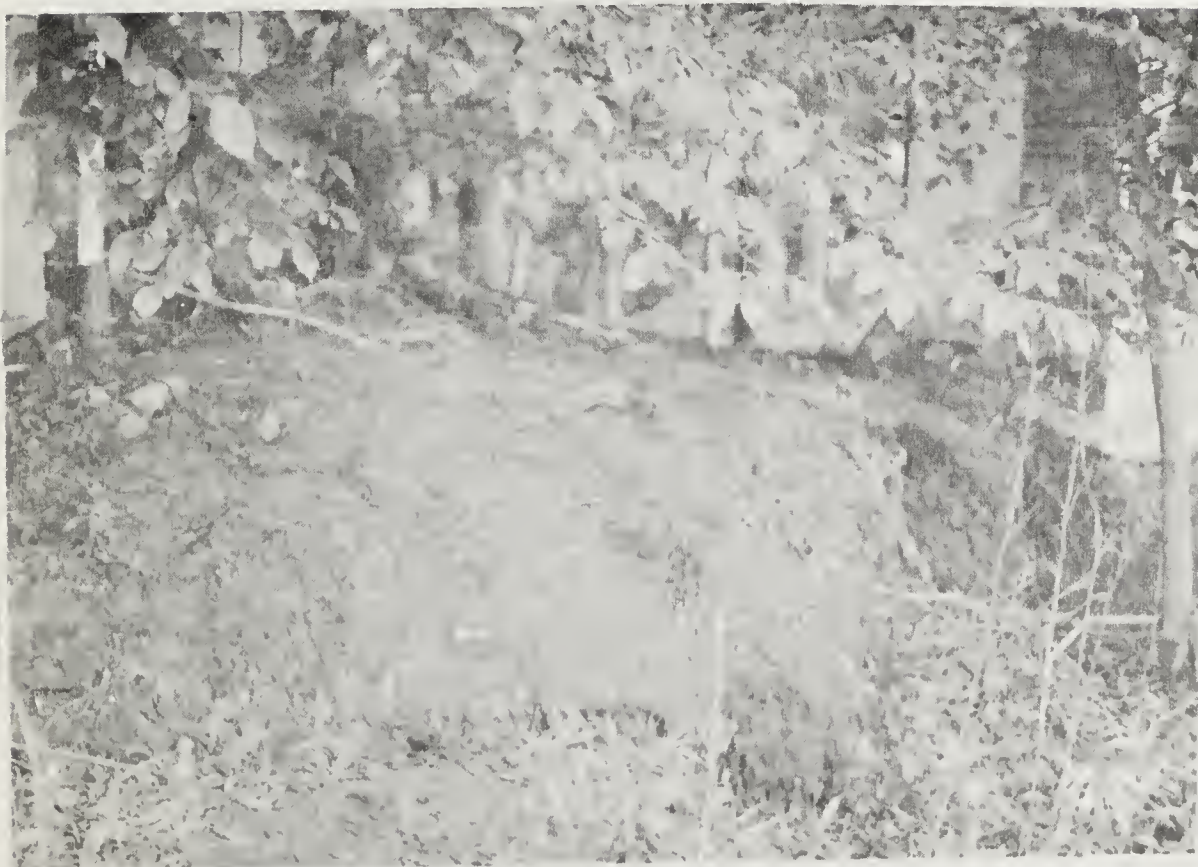
D

Slide scarp at structure foundation. 3 May 1977

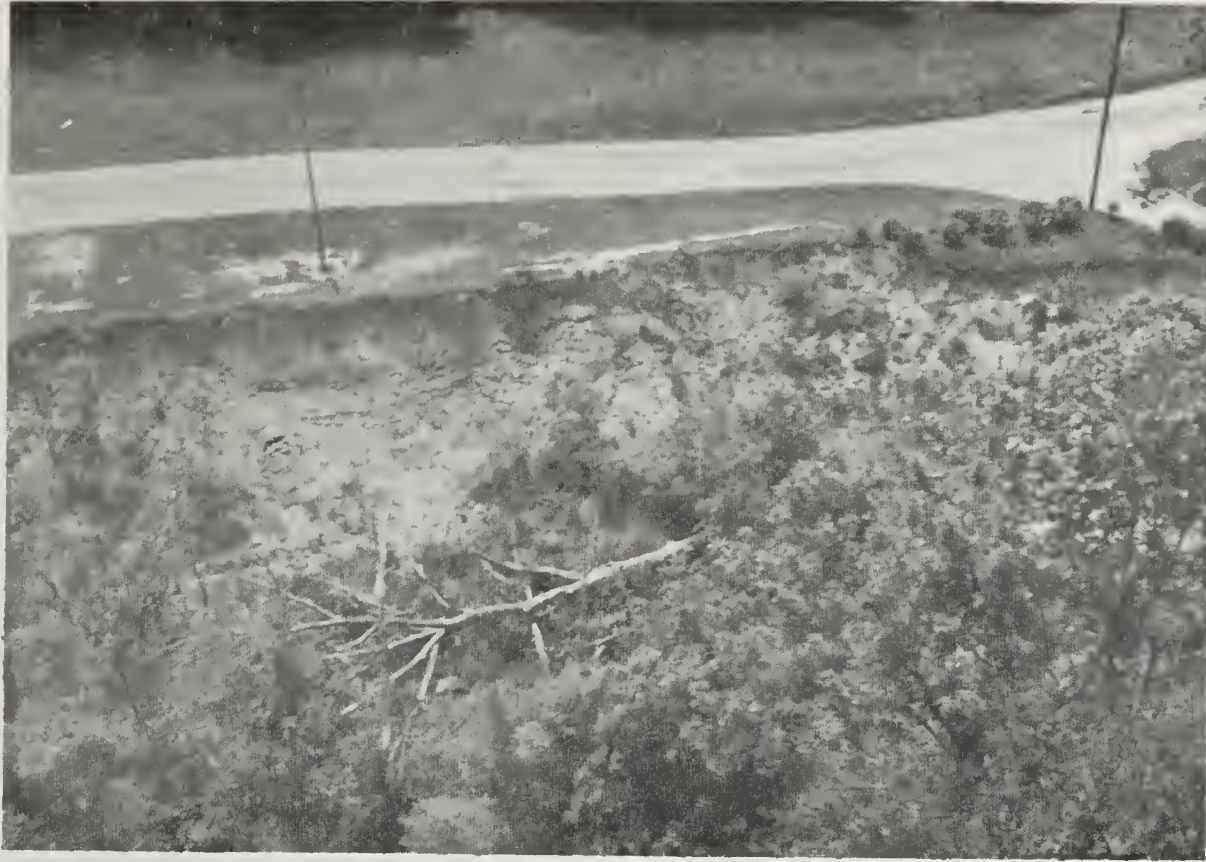
C

Slope failure exposed scarps and slumpage debris.
23 May 1977

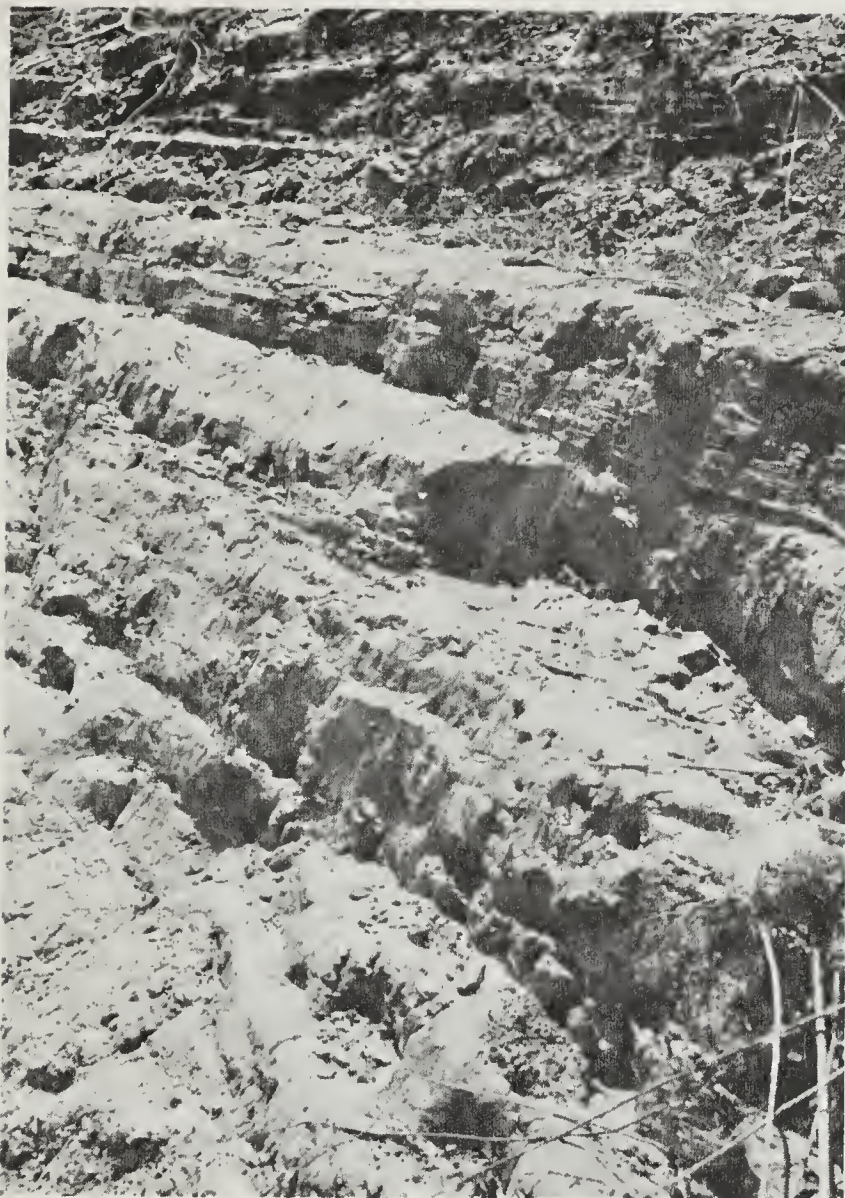
G

Outcrop of dense gray silt overlain by
iron-stained brown silt. 29 April 1977
